Adjustments

In use

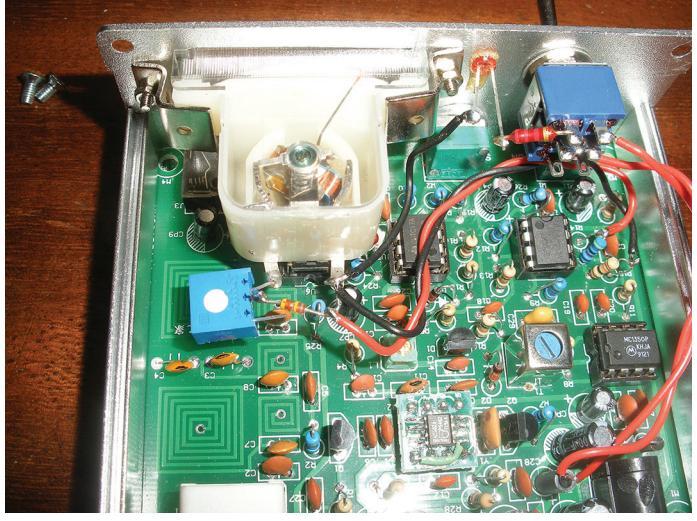
PHOTO 2: Behind the front panel. The meter, switch, LED, blue trimpot and associated parts are additions to the original. Note the meter fixings.

the meter need to be reversed, re-drilled (2mm) and fettled to fit. They are fixed with the two M2 screws supplied.

In Photo 2, the 50k pot and diode are seen soldered onto the meter terminals. The AGC take off point is below the power switch. The LED and series resistor is wired from the switch and the supply comes from the ferrite bead at the lower right, close to the DC input jack. The printed input band pass filter inductors can be seen on the left side of Photo 2.

You will also need to adjust T1 (blue core, metal case, centre right of Photo 2) for maximum noise.

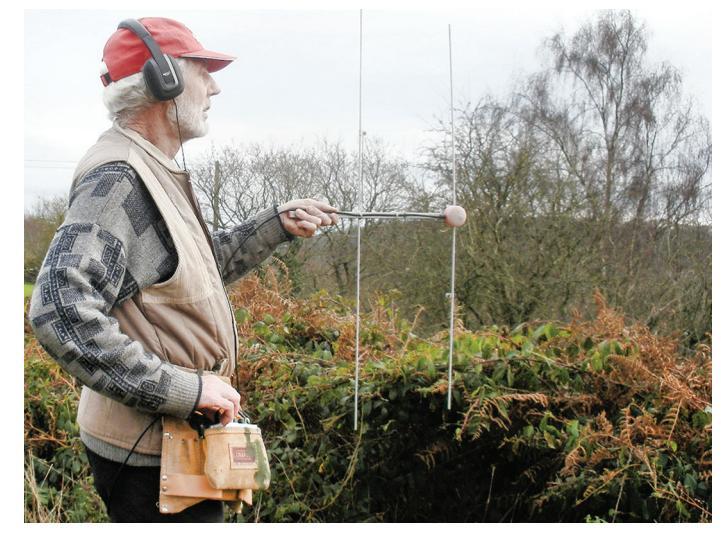
PHOTO 3: Using the receiver to trace the source of interference.

Using a tradesman's tool belt to carry the radio and battery (see Photo 3) made searching

much easier allowing the use of both arms to hold the antenna and tune the receiver for maximum interference. YOU MUST avoid <u>any</u> possibility of your antenna getting anywhere near overhead lines – the result could be fatal.
